Discovery STS-114

SSME Flight Readiness Review

June 29-30, 2005

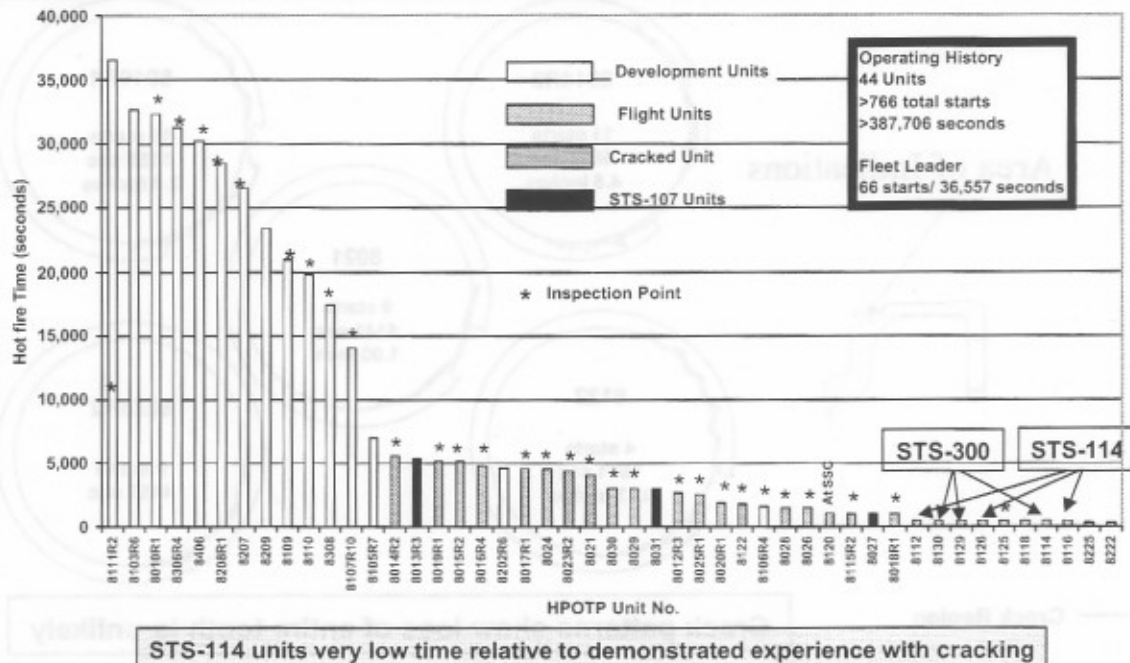
HPOTP Knife Edge Seal Inboard Seal (-072) Operational History

- Cracks and material loss found in knife edge 2-tooth seal during scheduled overhaul of 5 flight HPOTPs
 - Pump side tooth cracking and material loss on 4 of 5 seals
 - 3 of 5 had turbine side tooth cracking also (no material loss)
 - Pump side tooth cracking only (no material loss) on one seal
- Cracking and material loss had no significant impact on seal functionality or engine operation
